Manhole Inspection Summary

Manhole # S29EE_021MH

Insp Date: **1/9/07 11:47 AM**

Location Address: **1213 MADISON AVE**

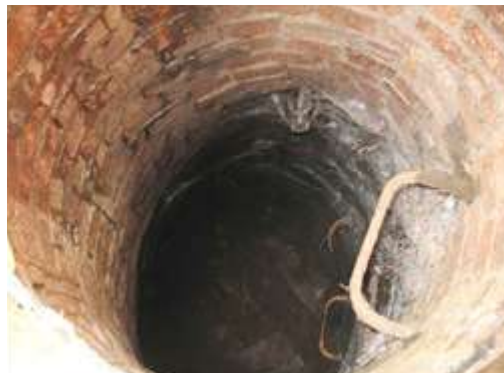
Top View

Barrel infiltration. Evidence of surcharge - Bench debris. Channel debris. Corroded and missing steps.

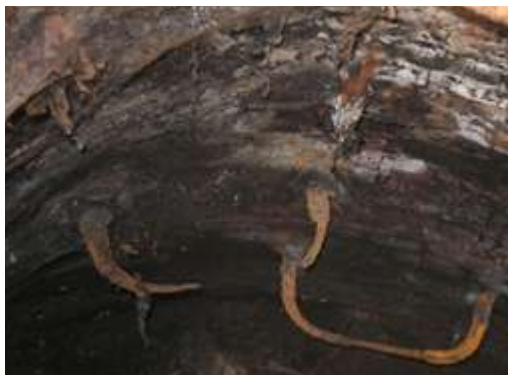
Defect

Corroded and missing steps, barrel infiltration

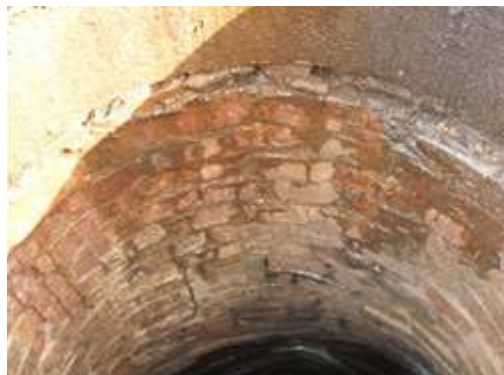
Defect

Frame leaks. Adjustment deterioration, loose brick and infiltration

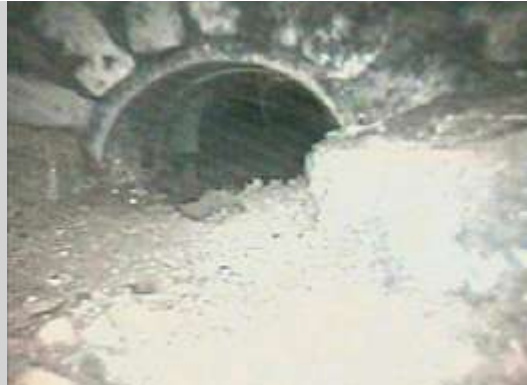
8 in. Circular Gravity Sewer Pipe Out @ 12 O'Clock

Deposits: ☐ None ☒ **Mud** ☐ Sludge ☒ **Debris** ☐ Grease

Silt Depth: **4** (in.) Deposits Extent: **Medium**

Infiltration: **Evidence** Pipe Seal Cond: **Unknown**

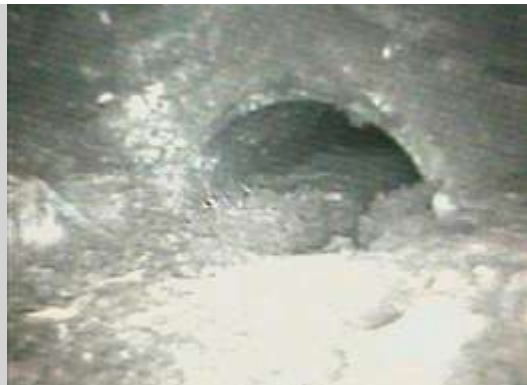
8 in. Circular Gravity Sewer Pipe In @ 5 O'Clock

Deposits: ☐ None ☒ **Mud** ☐ Sludge ☒ **Debris** ☐ Grease

Silt Depth: **3** (in.) Deposits Extent: **Medium**
